MACHINE SERVICE BULLETIN NO. 244

SUBJECT: LA 6-200-C Model

DATE: December 30, 1935

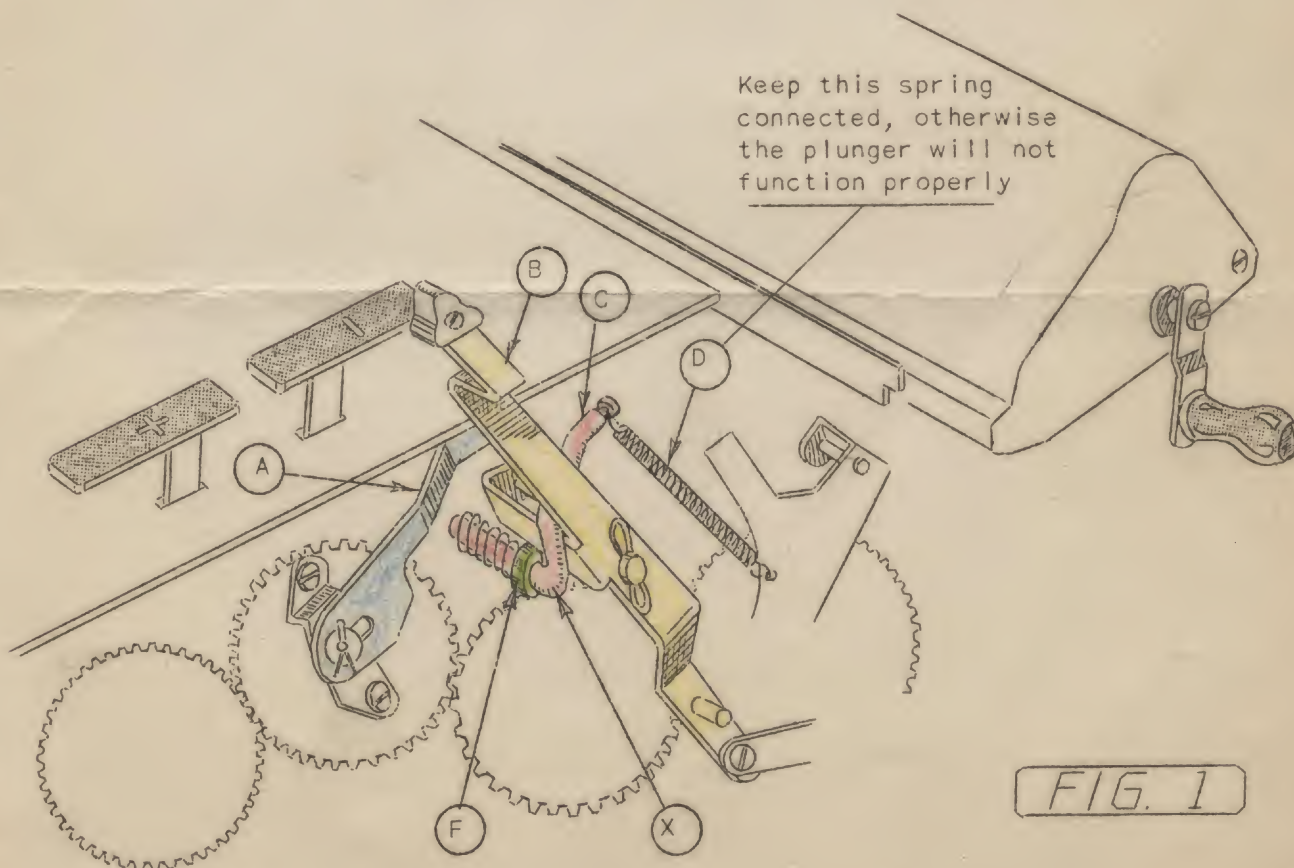
In addition to changes covered in Machine Service Bulletin No. 238, a change has also been made in the LA 6-200-C model whereby the machines will be equipped with a through-carry unit which does not contain trip levers 4310, trip lever shaft 4303½, overcarry trip lever 41-340½, screws 3007 or bearing 4309. Also a new trip lever 41-777x1 is used which is automatically disconnected during automatic multiplication by the use of a plunger rod. Long pins have been added to the 12th to 19th, inclusive, constant registering dial gears and a longer pin added to the last registering dial gear to compensate for the removal of the unit trip levers. A 47900 plunger engages the multiplication lever and extends through the side frames and the keyboard.

The left end of the plunger locates in a hole in a new style flexible end 41-779 which replaces the former 40-779, and also moves into engagement with the new 41-777x1 trip lever which replaces the 41-777. When the multiplication lever is returned to neutral, the trip lever is automatically coupled to the flexible end and serves as a regular trip lever when using the plus or minus bars or automatic division.

1. Stock has been removed from the 49070 counting finger (A) to avoid interference with the movement of the 47900 plunger rod. Figure 1
2. If, after the trip lever (K) and the 41-776 guide bracket (Z) have been adjusted the plunger rod (J) should strike the inner side of the 41-777x1 trip lever (K) instead of positioning over it as shown in Figure 3, remove stock from the top of lug (L) to suit,
